Locality: Place HEYFIELD
address: Citation 24 GEORGE STREET
date 2016 Hotel
Place type (when built): Local government level Local Planning Scheme: Yes Vic
Recommended heritage protection: Heritage Register: No
Heritage Inventory (Archaeological): No

Place name: Railway Hotel

Project: Wellington Shire Stage 2 Heritage Study
Client: Wellington Shire Council
Author: Heritage Intelligence Pty Ltd
Date: 12/2/16

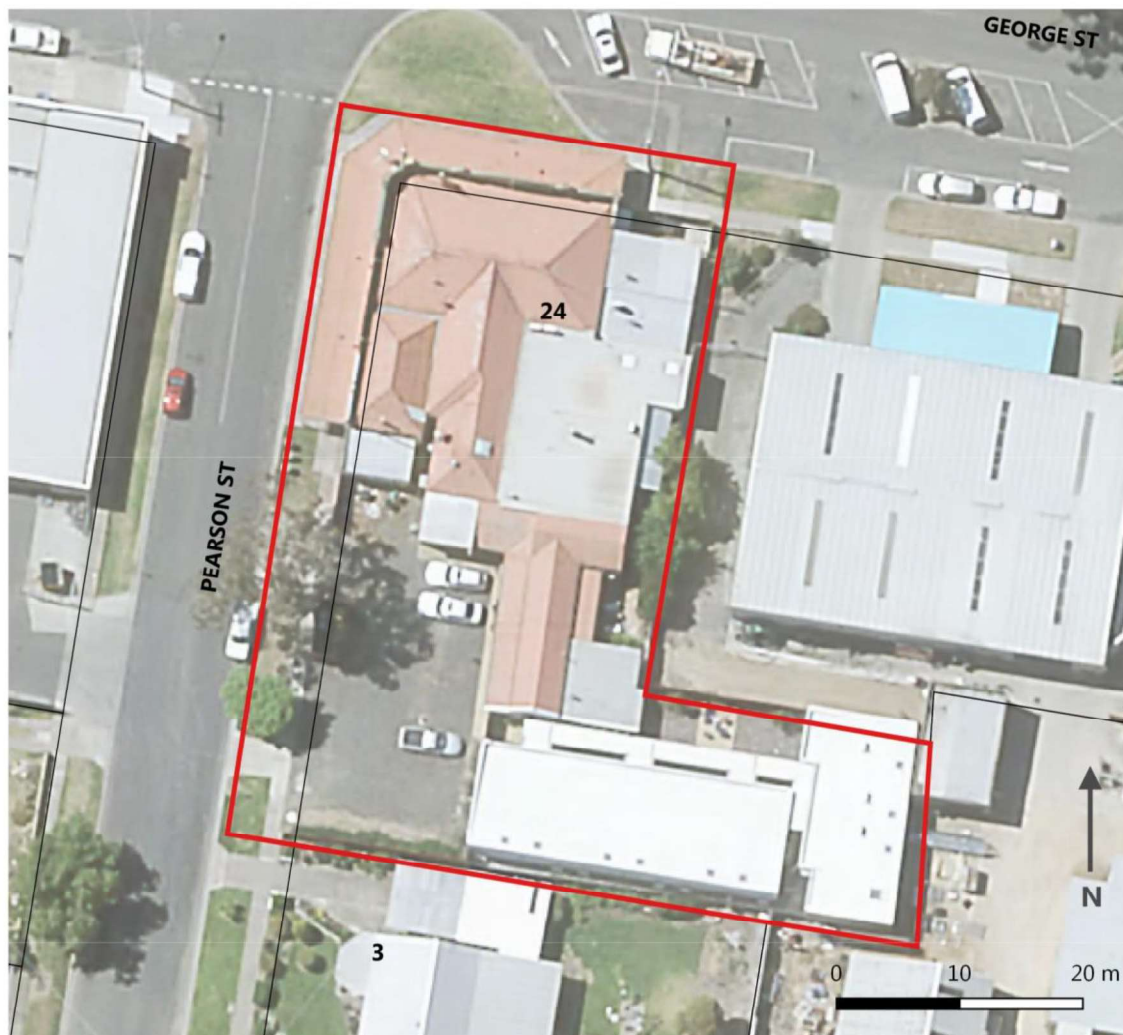
Map of recommended boundary for Heritage Overlay

This place is recommended for inclusion in the Schedule to the Heritage Overlay of the Wellington Shire Planning Scheme to the boundaries as shown on the map.

[extended to cover the verandah]

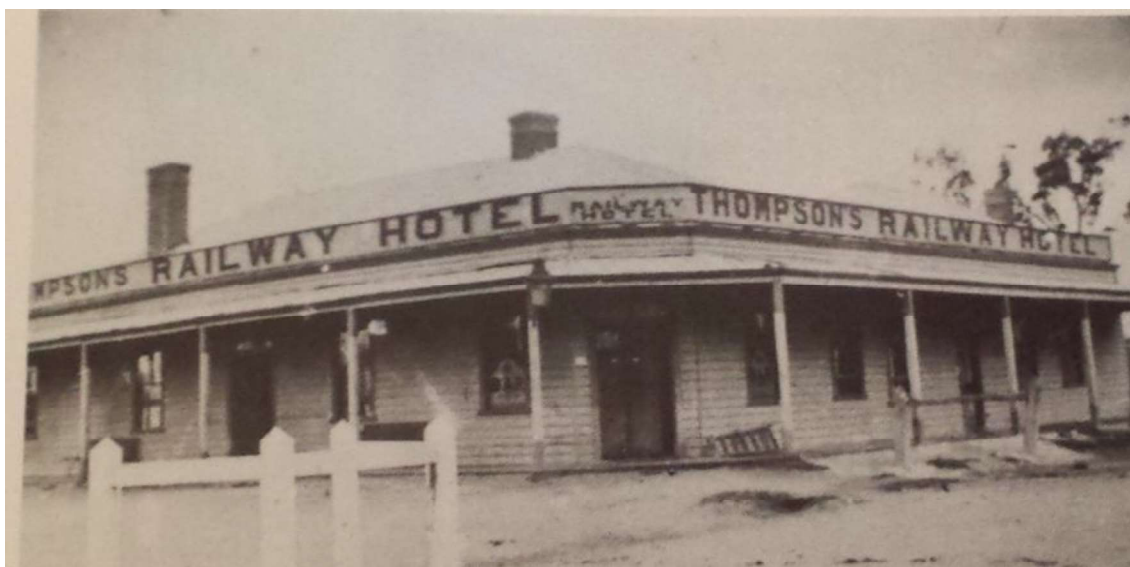
Figure H1. A photo dating to c1895 of the 'Thompson's Railway Hotel'. The photo shows the corner weatherboard building with a low parapet reading 'Thompson's Railway Hotel'. A hipped roof with two brick chimneys ran parallel to George Street, while a second hipped roof ran parallel with Pearson Street. A chamfered corner held the main entrance to the hotel, below a slightly concave skillion-roof verandah that continued along the two main elevations (FitzGerald 1991:21).

Bridget Clark subdivided the lots (around the existing hotel) and on-sold or leased them out from 1899, but retained the hotel and its property (LV:V1657/F252). A photo dating to c1895 (Figure H1) showed the corner timber building with a low parapet reading 'Thompson's Railway Hotel'. A hipped roof with two brick chimneys ran parallel to George Street, while a second hipped roof ran parallel with Pearson Street. A chamfered corner held the main entrance to the hotel, below a skillion-roof verandah that continued along the two main elevations (FitzGerald 1991:21).

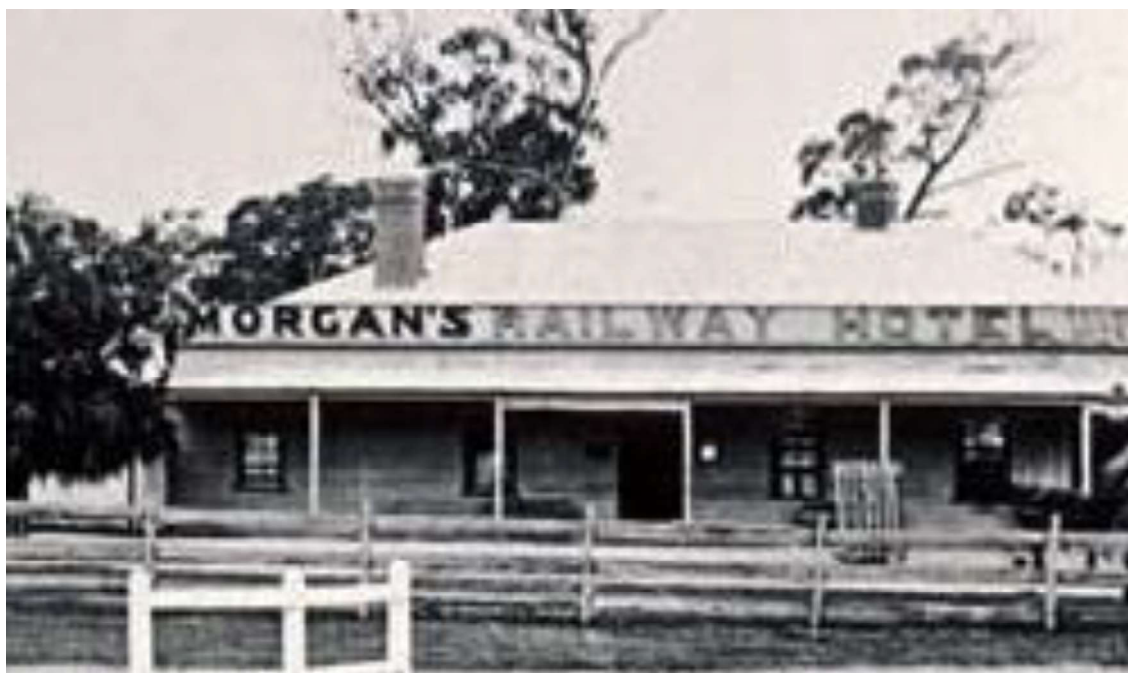
Figure H2. This photo dating to c1911 showed 'Morgan's Railway Hotel'. The hotel had a verandah, hipped roof and retained two brick chimneys (since removed) (HDHS).

In 1911, the Victorian Post Office Directory listed John Morgan as the proprietor of the Railway Hotel, located opposite the railway station, with 'superior accommodation for travellers; only best brands all liquor and cigars; charges moderate; billiards; horses and buggies for hire' (VPO Directory 1911). A photo dating to c1911 (Figure H2) showed 'Morgan's Railway Hotel' painted on a low parapet along the main facade (fronting George Street). The hotel had a verandah, hipped roof and retained two brick chimneys (since removed) (HDHS; FitzGerald 1991:20).

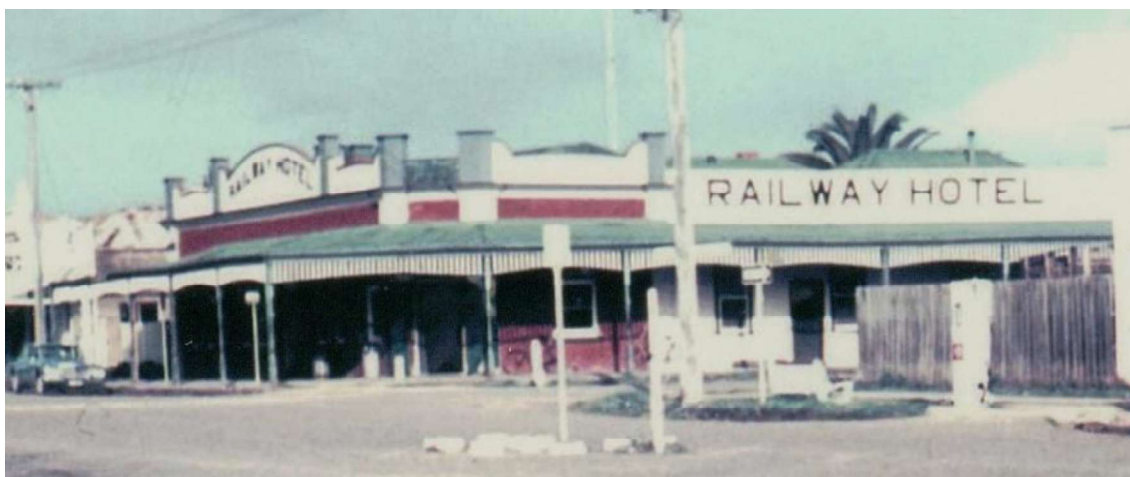
Figure H3. Photo dating to c1970s that shows the hotel with a timber parapet on the right hand side, and timber frieze (with vertical slats) running the length of the slightly concave skillion verandah at this date. The roof cladding was coloured green and 'Railway Hotel' was written on the shorted parapet fronting Pearson Street (HDHS).

In the 1940s, the hotel provided accommodation (*Gippsland Times*, 5 Feb 1945:3). A photo dating to the c1970s (Figure H3) showed the hotel with a timber frieze (with vertical slats) running the length of the verandah at this date. The roof cladding was coloured green and 'Railway Hotel' was written on the shorted parapet fronting Pearson Street (HDHS).

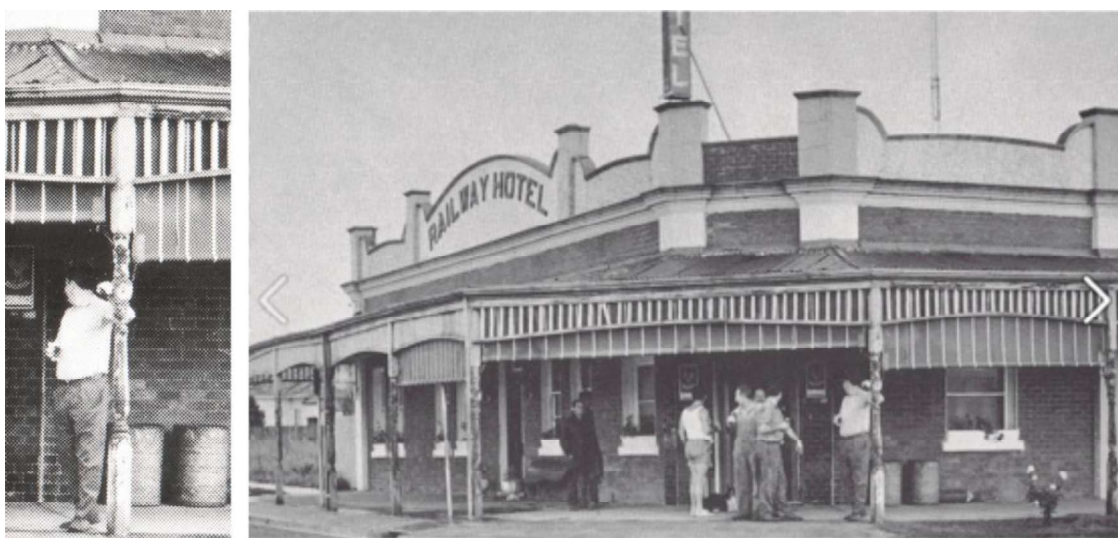
Figure H4. Photo showing the unpainted red brickwork, and the window and door fenestration which appears to match the Victorian era windows shown in Figures H1 and H2. The highly decorative turned timber posts and timber verandah valence are typical of the Federation era design (see inset detail). Although this photo was taken in 1975 the building, including the verandah, as seen in this photo, is virtually unchanged from its appearance when it was built c1918.

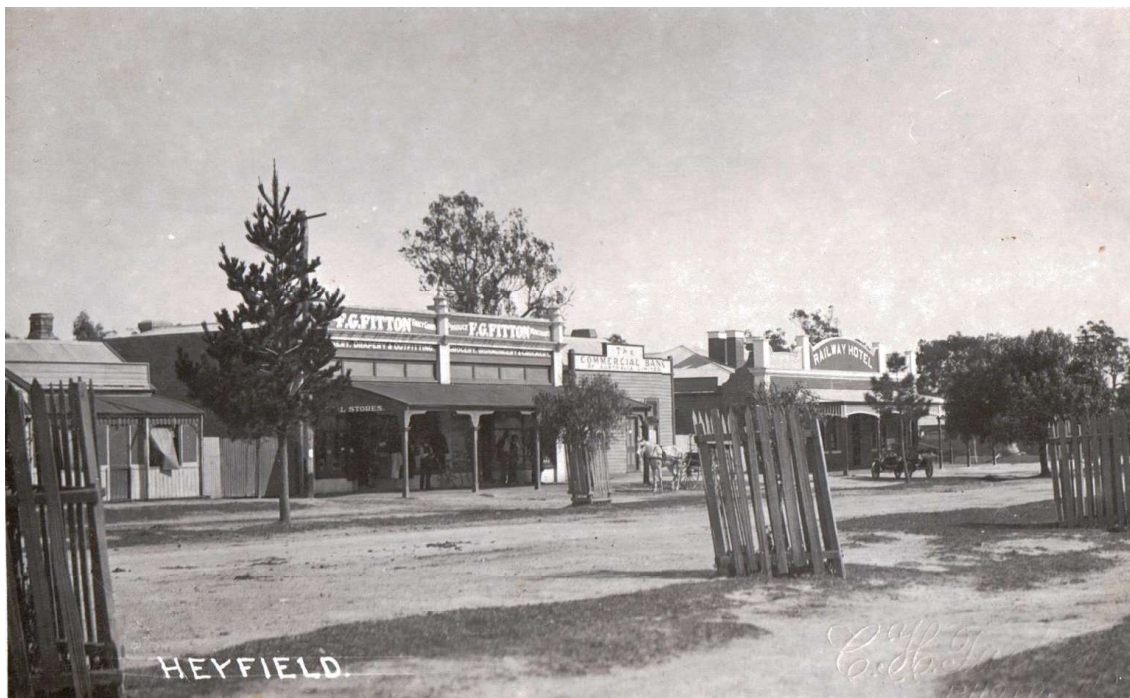
Figure H5. c. 1920s view of George St, Heyfield. Showing the George St elevation soon after it was constructed, was the same as in the 1975 photo in Figure H4. The tones of the colour scheme is also evident, such as the unpainted red brickwork, dark and light coloured rendered parapet, unpainted galvanised iron roof cladding, dark coloured verandah fascia and posts, and light coloured timber slatted verandah. It also shows the timber Commercial bank building owned by Bridget Clark.

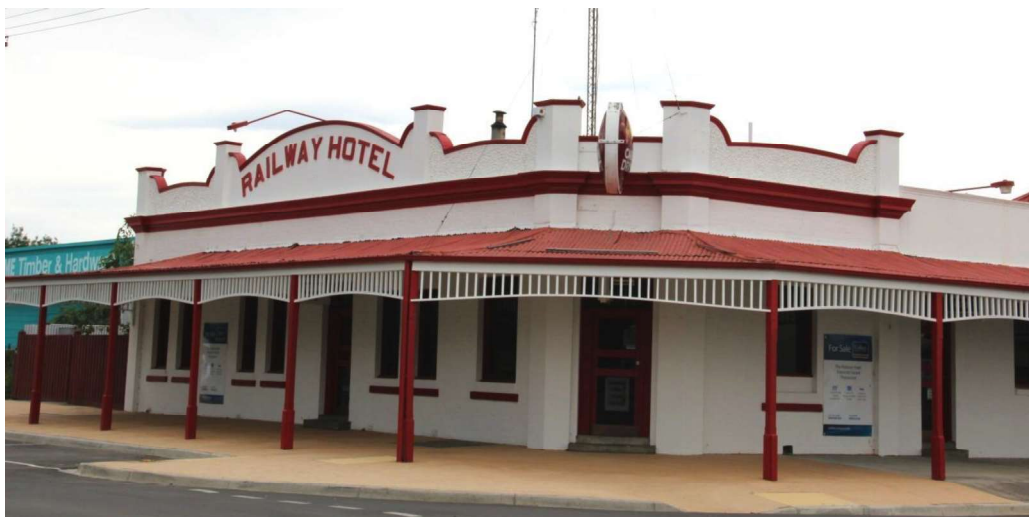
Figure D1. The two main elevations of the hotel have a brick parapeted facade (overpainted) which extends above the verandah roof to form an ornate parapet, which conceals the Victorian buildings with hipped roofs behind them. The north elevation, corner bay and adjacent bay on the west elevation retain tuck pointing to the bricks (overpainted). An entrance is located on the chamfered corner, entered by two concrete steps. The parapet extends across the entire north elevation and part of the west elevation, past the corner entrance. The rendered (overpainted) parapet is formed by rendered engaged piers which extend from ground level. In between the piers are shorter sections which rise in a slight arch, faced with rough-cast render. At the centre of the north parapet is a large section which rises in a larger arch, with the words 'Railway Hotel' in relief. Below the parapet on both elevations is a bold cornice mould.

A modern sign projects from the parapet at the corner.

Figure D1. The two main elevations of the hotel have a brick envelope (overpainted) which extends above the verandah roof to form an ornate parapet, which conceals the Victorian hipped roof. An entrance is located on the chamfered corner. The parapet extends across the entire north elevation and part of the west elevation, past the corner entrance.

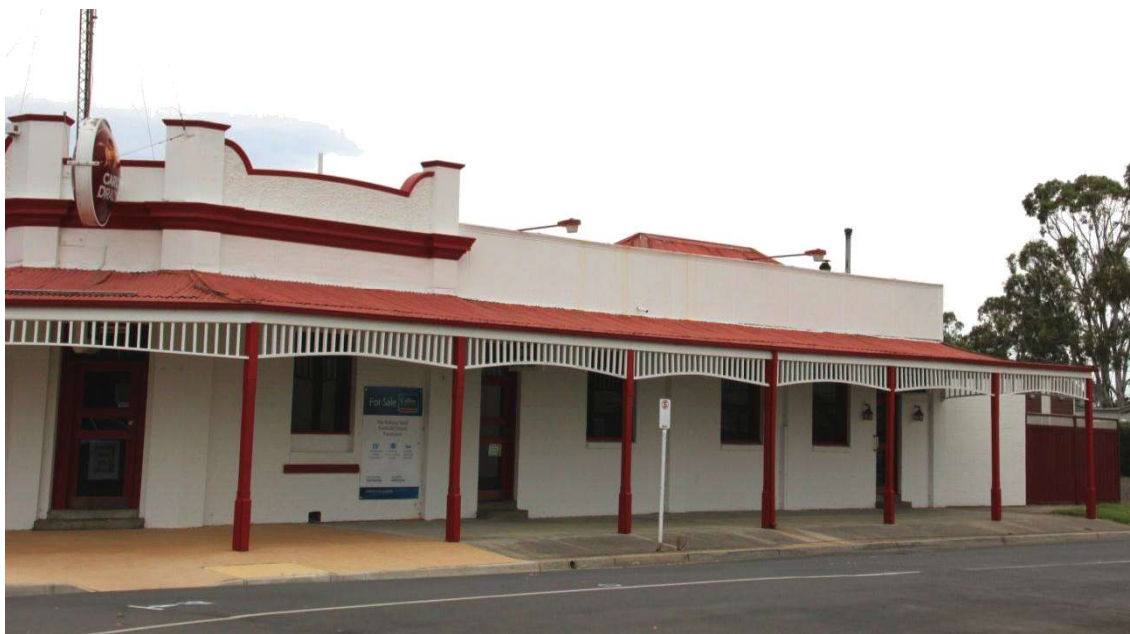
Figures D1 & D2. The hipped verandah has a slightly-concave profile and is clad with corrugated iron, supported by (new – see Figure H4) stop-chamfered timber posts which have been spliced in to the top of the original turned timber posts (just below the timber valance). The verandah has a timber frieze with vertical slats that date from the original c1918 structure. A shorter parapet constructed of simple panels is located at the south end of the west elevation (date not confirmed).

Figure D2. A shorter parapet constructed of simple panels is located at the south end of the west elevation (date not confirmed).

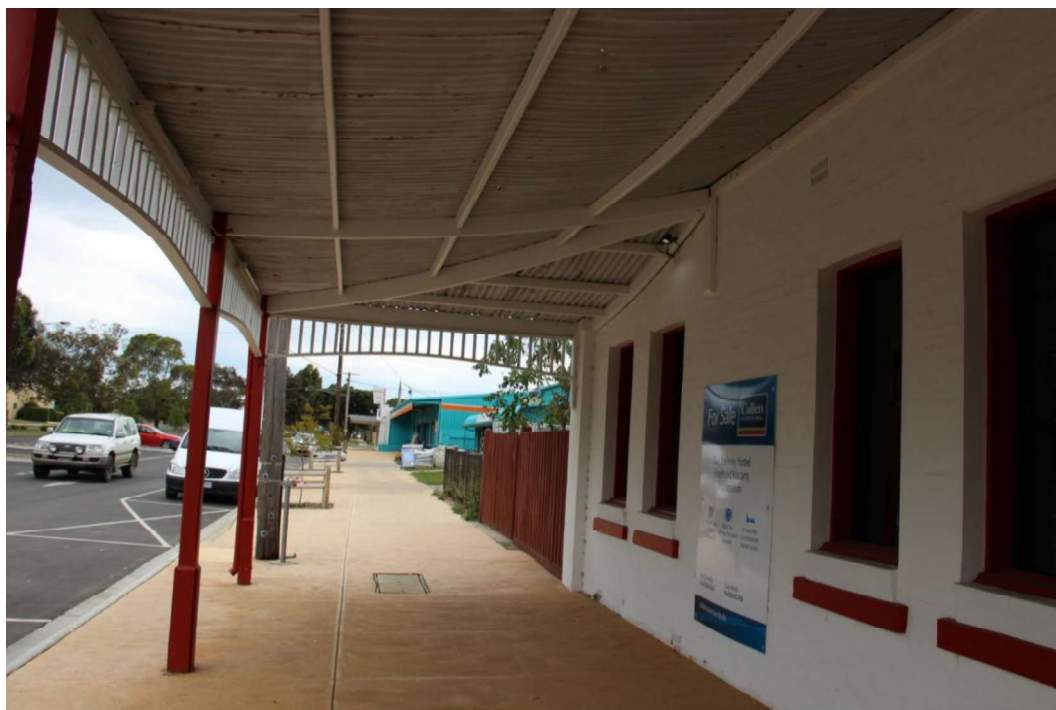
Figures D1, 2 & 3. The openings to the north and west elevations appear to be very similar in layout to the Victorian facades (see Figures H1 & H2). The windows have a rendered sill with a wide rendered band below (overpainted), dating to the c1918 development.

All of the doors and windows to the north and west elevations are modern alterations.

Figure D3. The openings to the north and west elevations appear to be very similar to the Victorian era openings, in the Victorian facades (see Figures H1 & H2). Note the concave verandah structure.

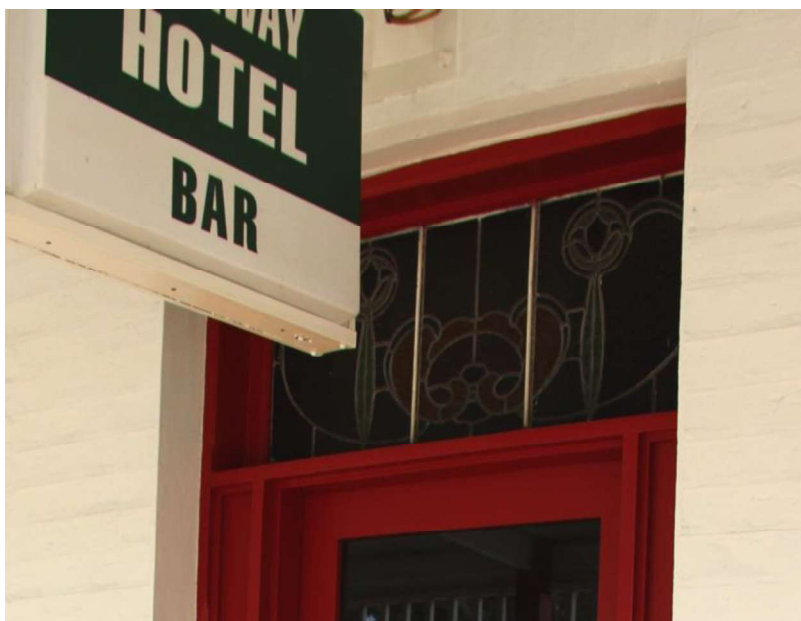
Figure D4. The corner entrance and entrance on George Street retain leadlight highlights with an Art Nouveau influence which date from the c1918 works.

Figure D4. The corner entrance retains leadlight highlights with an Art Nouveau influence dating from the c1918 construction.

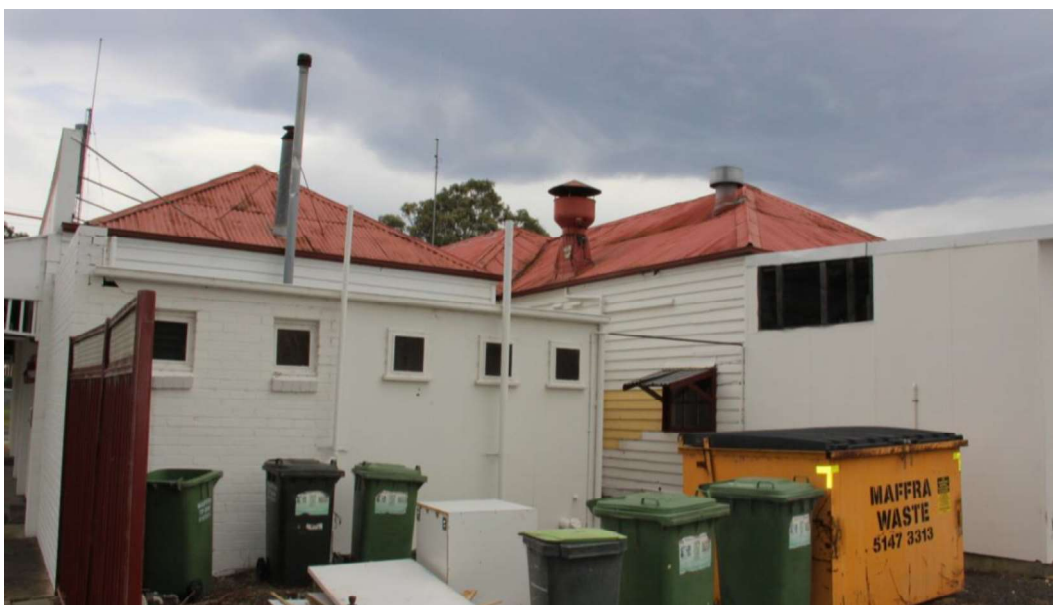
Figure D5. The rear (south) elevations, dating to the Victorian period, are clad in weatherboard, with the hipped roofs evident above.

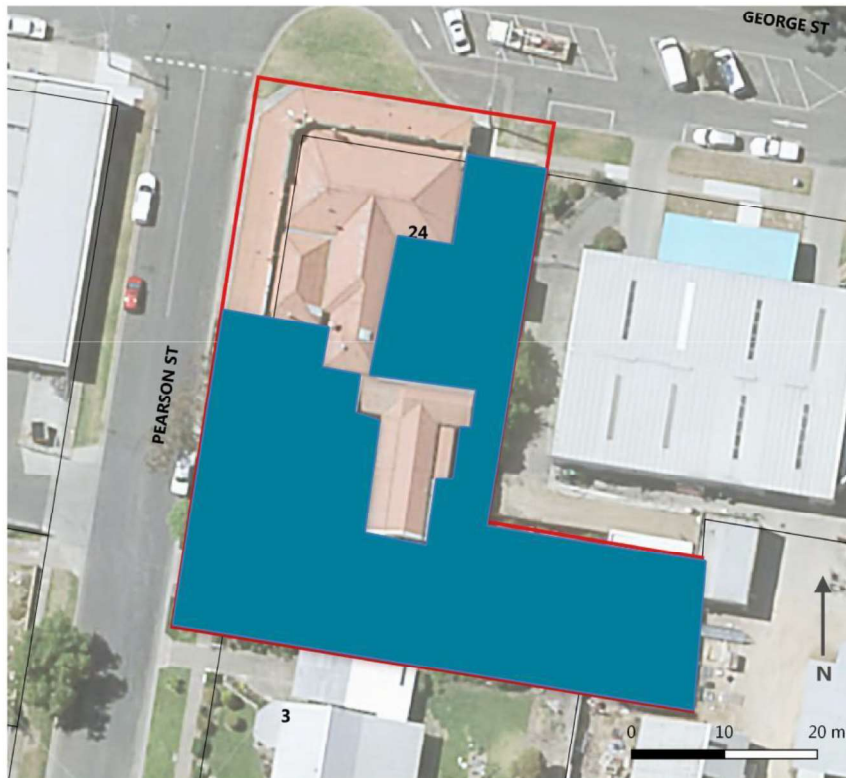
NOTE: The blue shaded area is the preferred location for additions and new development
