Locality: HEYFIELD
Place address: 15 TEMPLE STREET
Citation date 2016
Place type (when built): Memorial Church
Recommended heritage protection: Local government level
Local Planning Scheme: Yes
Vic Heritage Register: No
Heritage Inventory (Archaeological): No

Place name: St James Anglican Soldiers Memorial Church & Memorials

Architectural Style: Interwar Gothic
Designer / Architect: Clegg and Morrow (Not confirmed)
Construction Date: 1920

Project: Wellington Shire Stage 2 Heritage Study
Client: Wellington Shire Council
Author: Heritage Intelligence Pty Ltd
Date: 12/2/16

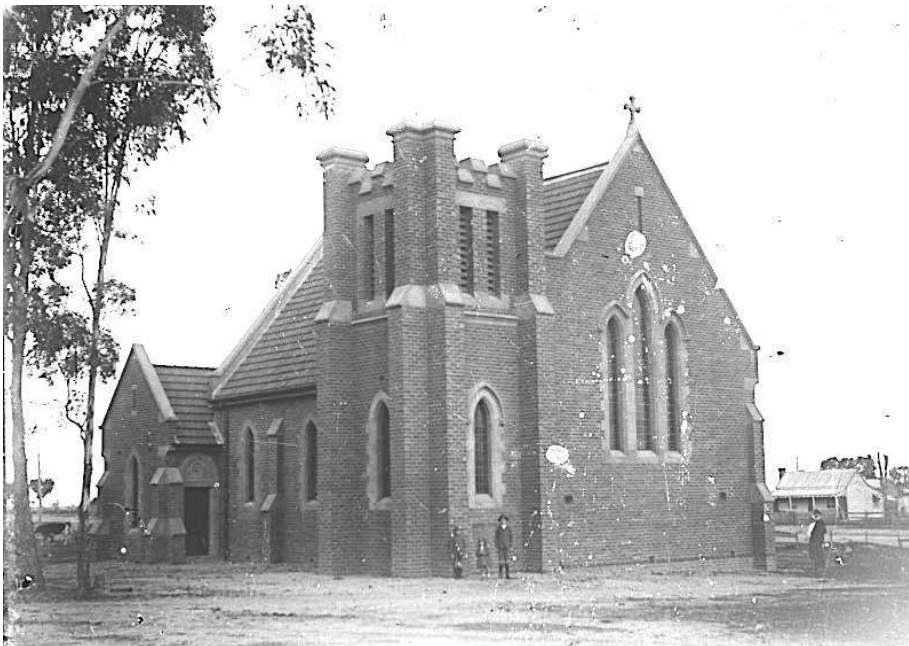
An early photo (Figure H1) showed the substantial church towering above slight figures who stand in the un-landscaped grounds. The facade and north elevation of the church were visible, with the large bell tower, as they appear today. A long vertical air vent is located at the facade's gable-end (since covered with a large cross). The small room (possibly a vestry) projects off the chancel at the eastern end. A second black and white photo of the church (date not known; Figure H2) shows the church, tower and chancel end from the south-east. A timber-framed and wire fence runs along the front of the church, in close proximity (since removed). A young palm is located behind (since removed) (FitzGerald 1991:60).

Figure H1. An early photo of the substantial church towering above slight figures who stand in the un-landscaped grounds (HDHS).

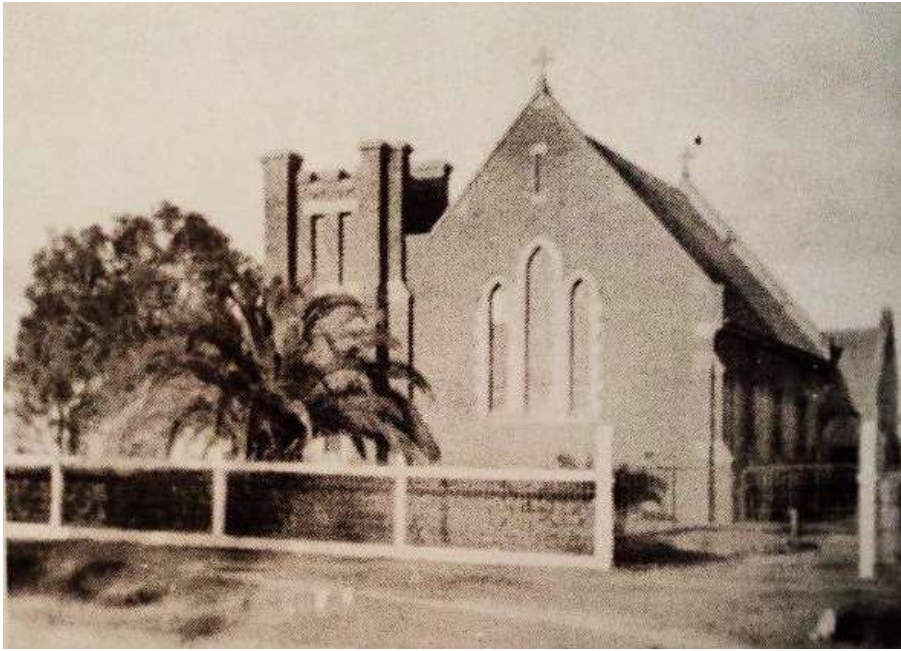
Figure H2. Photo of the church and chancel end from the south-east. A timber-framed wire fence runs along the front of the church, in close proximity (since removed) (Back to Heyfield 1991:60).

4.5.1. Reconstruct the timber and wire fence along the Temple Street boundary (see Fig H2).

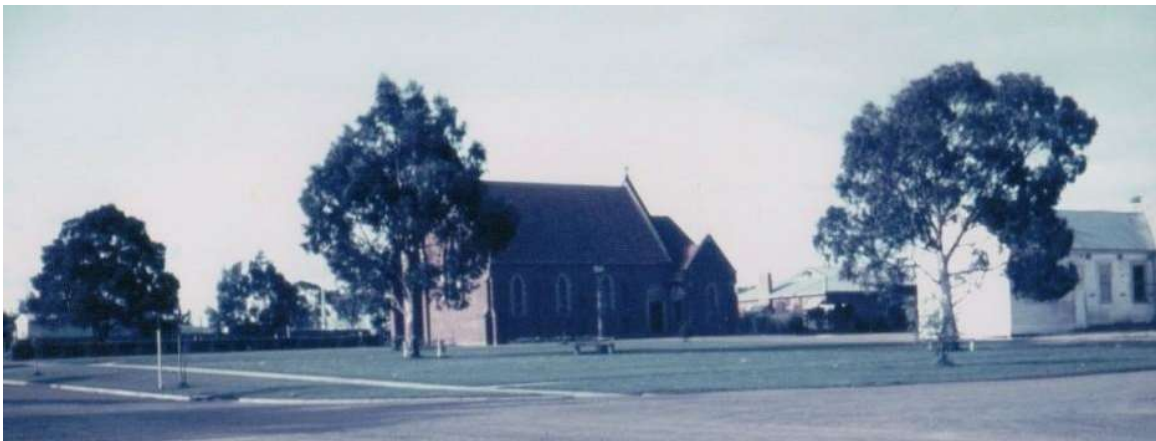
Between 1954 and 1984, a timber church hall was located on the site. The hall was the former Mechanics Institute which was built on MacFarlane Street in the early 1880s. It was moved to Temple Street in 1954 and used as St James' Anglican Church hall until it was demolished in 1984. It was a weatherboard building with ornate bargeboards and pinnacles, in a Picturesque Gothic style (FitzGerald 1991:14). A photo dating to the c1970s (Figure H3) shows the church hall located near the southern boundary (HDHS). On 11 November 1974, the church celebrated its centenary (FitzGerald 1991:60).

Figure H3. A c1970s photo of the church and hall. Between 1954 and 1984, a timber church hall was located on the site. The hall was the former Mechanics Institute which was built on MacFarlane Street in the early 1880s. It was moved to Temple Street in 1954 and used as St James' Anglican Church hall until it was demolished in 1984. (HDHS).

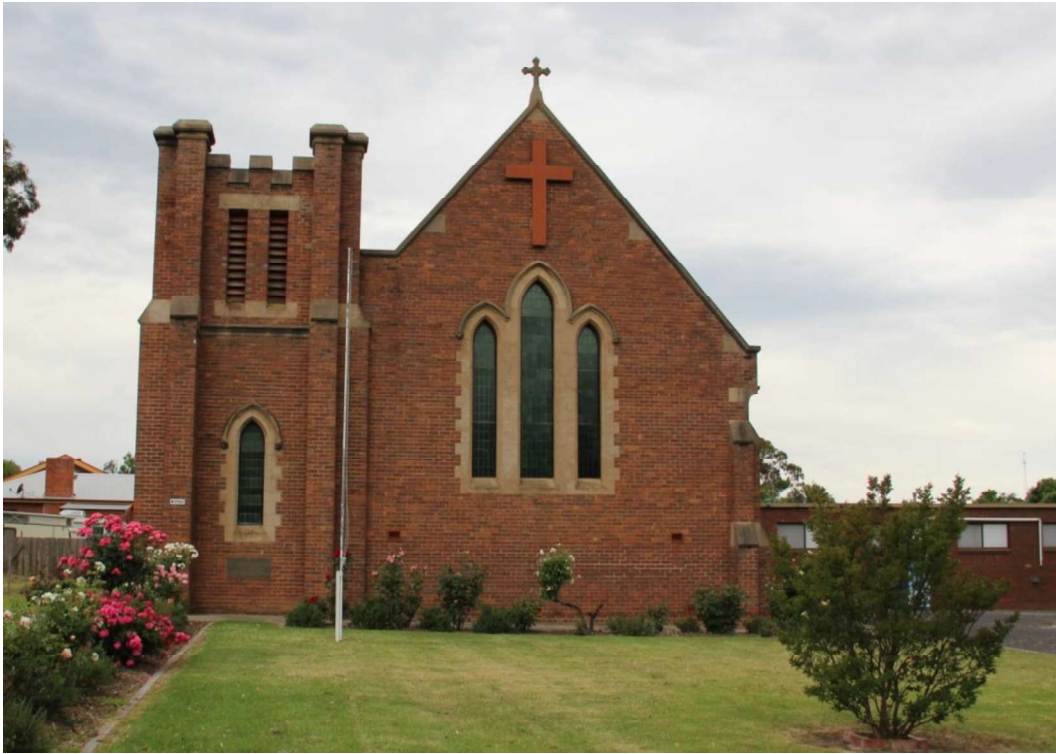
Figure D1. The substantial (handmade) red-brick church has a steeply-pitched gable roof clad in terracotta tiles that is hidden from Temple Street by a parapeted gable, with a cross at the peak. A dominant and tall castellated bell tower is located to the left of the facade. The top portion of the tower has tall narrow louvered vents, while the bottom portion has pointed-arch windows with label moulding. Brick buttresses repeat on the corners of the facade and tower (where they extend to the height of the tower). Rendered dressings and coping (that remain unpainted) appears on the parapets, buttresses, door and window surrounds (the windows with rendered quoining) and tower castellation. A large cross has been placed over a vent at the top of the gabled-end of the facade. In front of the church is a flagpole.

Figure D1. The substantial (handmade) red-brick church has a steeply-pitched gable roof that is hidden from Temple Street by a parapeted gable, with a cross at the peak of the gable. A dominant and tall castellated bell tower is located to the left of the facade.

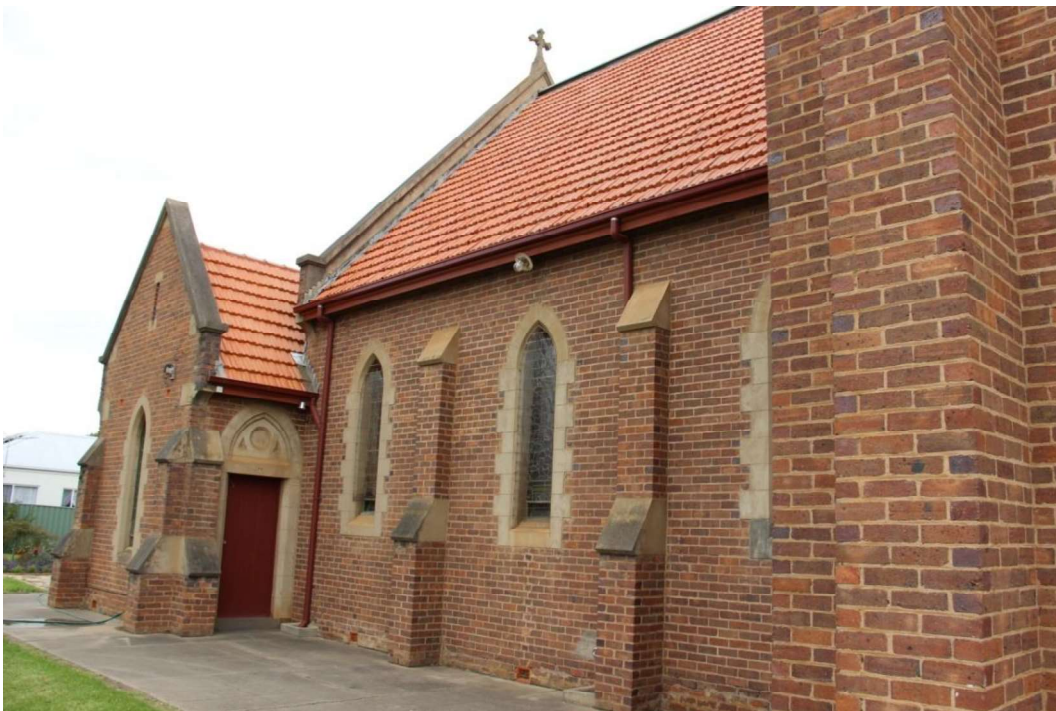
Figure D2 & D3. The gabled roof of the nave and eastern sections of the church are clad with terracotta tiles, as evident from the side elevations. The side elevations are divided into four bays by tall buttresses. Each bay consists of one pointed-arch window with pictorial or geometric coloured leadlight. Timber ledged and framed doors on the side elevations and vestries have a bold pointed-arch pediment with a trefoil motif, surmounted by a label moulding stopped by rosettes. The main entrance to the church is on the east side of the bell tower.

The north elevation contains two pictorial leadlight memorial windows towards the chancel end.

Figure D2. The north elevation. The gabled roof of the nave and eastern sections of the church are clad with terracotta tiles, as evident from the side elevations. The side elevations are broken into four bays by tall buttresses. Each bay consists of one pointed-arch window with quoining, and pictorial or geometric coloured leadlight. The north elevation contains two pictorial leadlight memorial windows towards the chancel end.

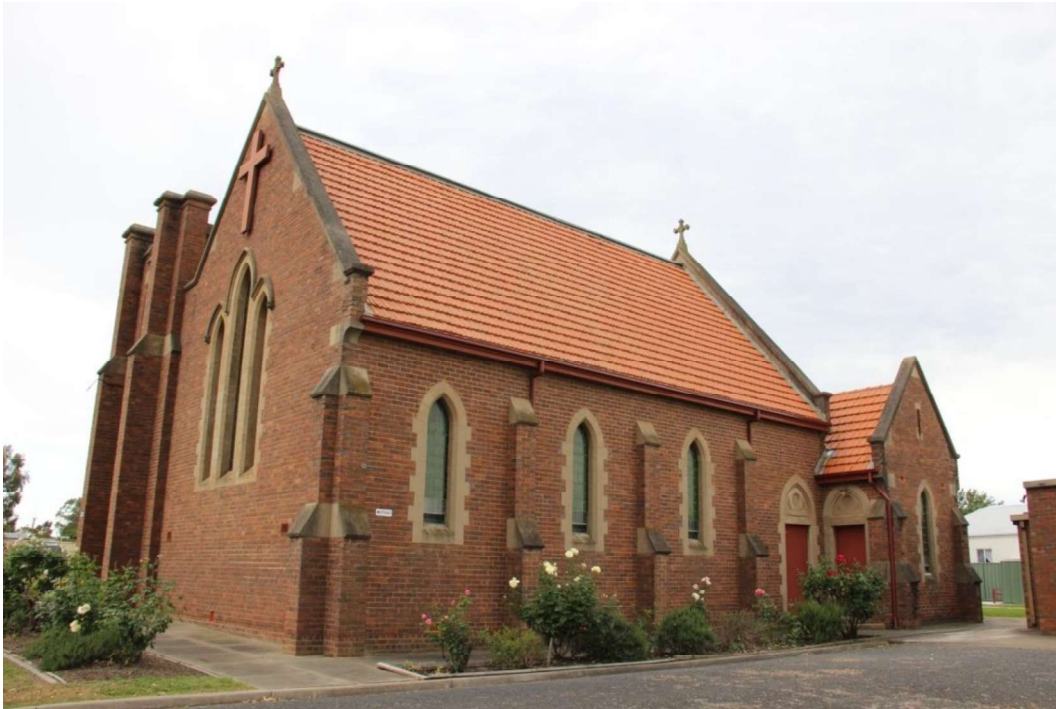
Figure D3. The south elevation. Timber ledged and framed doors on the side elevations and vestries have a bold pointed-arch pediment with a trefoil motif, surmounted by a label moulding stopped by rosettes. At the east end of the nave are vestries, which project to the north and south off the central chancel, which have the same treatment as the main portion of the church.

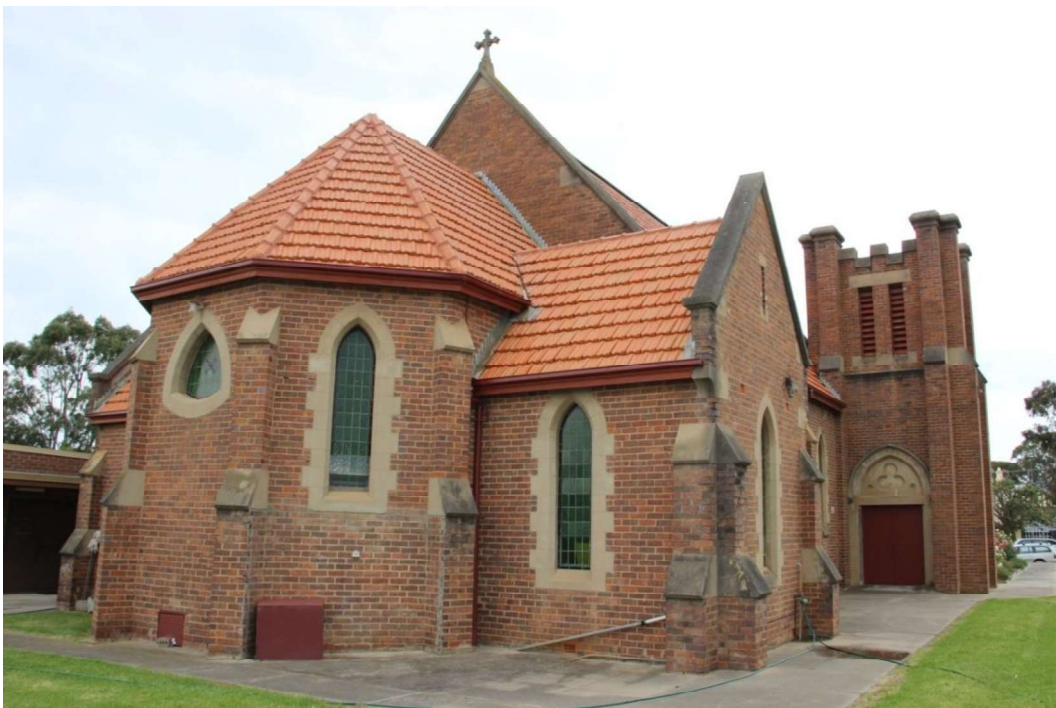
Figure D4. At the east end of the nave are vestries, which project to the north and south off the central chancel, which have the same treatment as the nave of the church. The chancel is a faceted bay, also with the same treatment as the nave. Buttresses at the corners of the bay separate pointed-arch windows with leadlight and a central small window in a triangular shape, with leadlight (with a floral motif).

Figure D4. The east end of the church. The chancel is a faceted bay, also with the same treatment as the nave. Buttresses at the corners of the bay separate pointed-arch windows surrounded with quoining, with leadlight and a central small window in a triangular shape, with leadlight (with a floral motif).

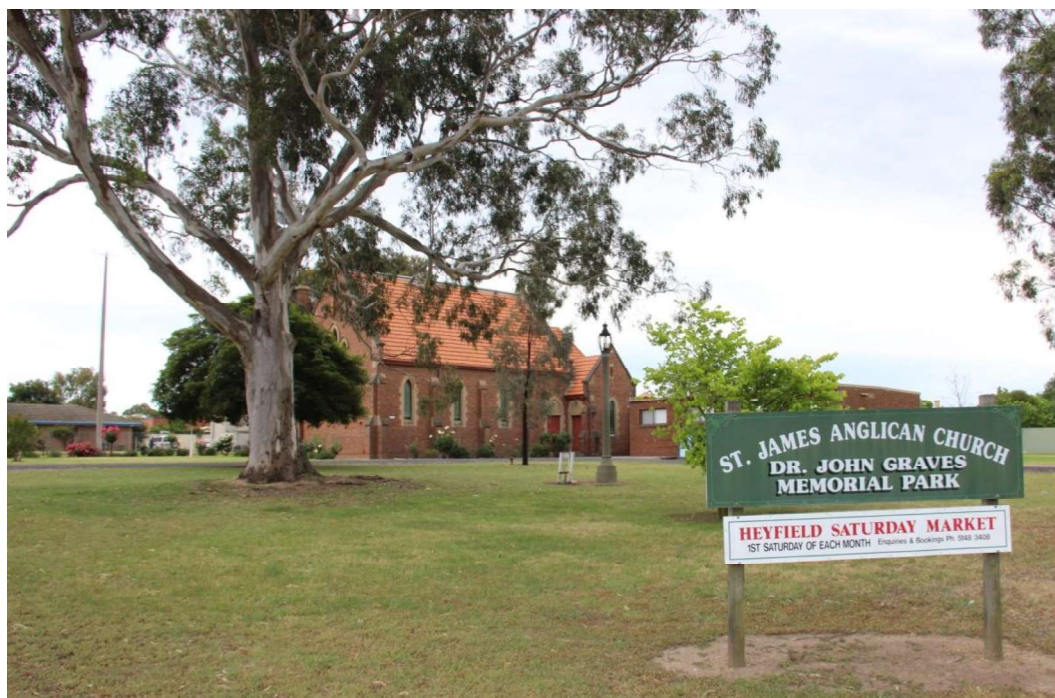
Figure D5 & Aerial. To the south-east of the church are various outbuildings including small sheds and a modern brick building. At the south-west section of the property is Dr John Graves Memorial Park, which provides a setting for the church. At the centre of the park is an electric lamp (date not known).

Figure D5. To the south-east of the church are various outbuildings including a modern brick building. At the south-west section of the property is Dr John Graves Memorial Park, which provides a setting for the church. At the centre of the park is an electric lamp (date not known).

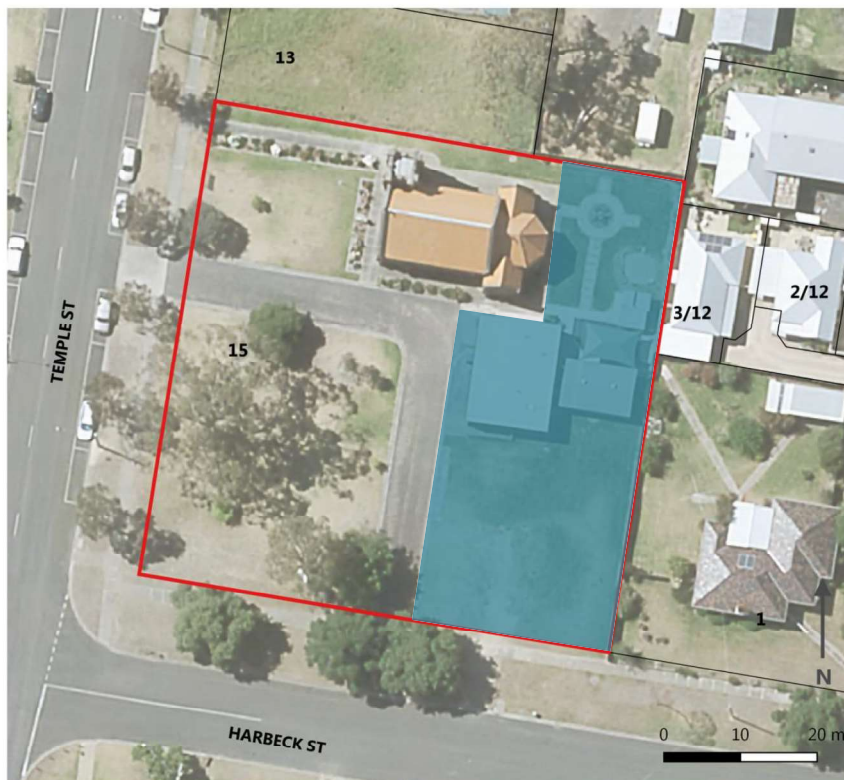
NOTE: The blue shaded area is the preferred location for additions and new development:

2. **Additions And New Structures**
 - 2.1. New structures should be restricted to the rear of the property as shown in the blue polygon on the aerial map below.
